TWR-17543 Vol. IV

Flight Set 360T004 (STS-30)  
Seals Final Report

March 1990

Flight Set 360T004 (STS-30)  
SEALS FINAL REPORT  
Volume IV

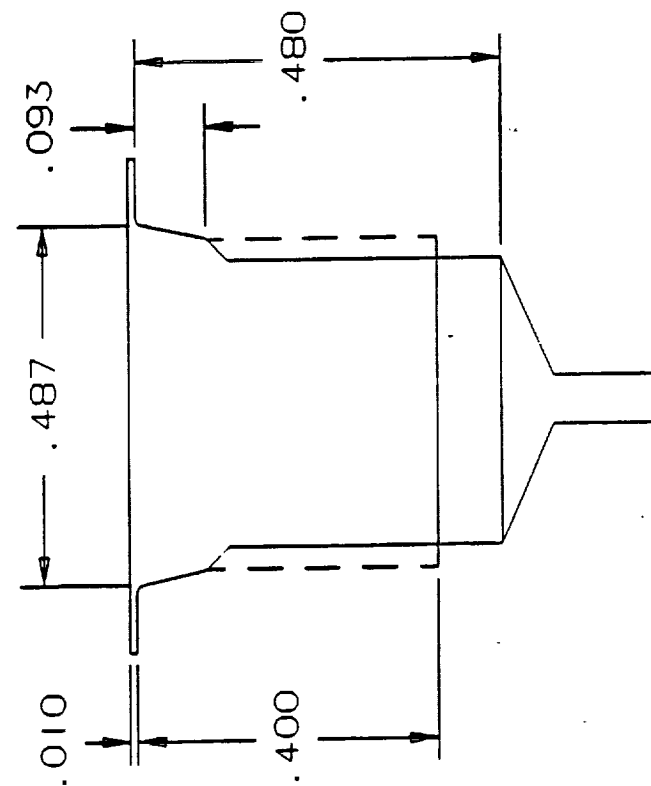
DR 169706

PORT CONFIGURATION (Min)

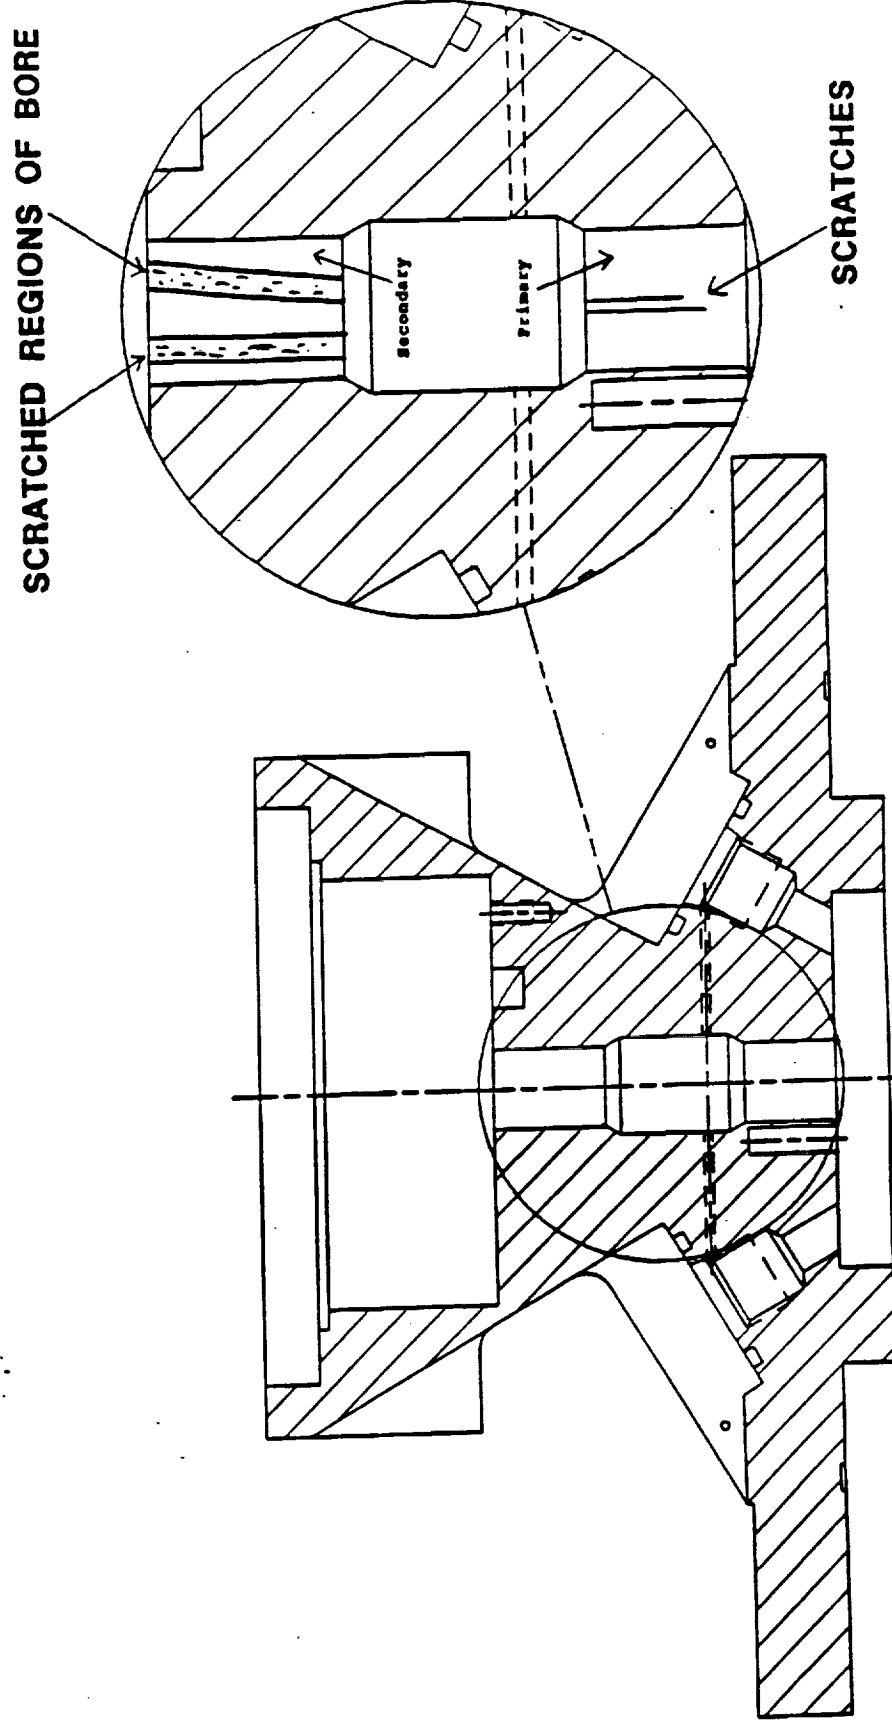
Scratches, found on 4th flight (360L004) Barrier-Booster housing bores, were not found prior to assembly.

- Units built after 4th flight could have unacceptable scratches.
